MARINE INVESTIGATION REPORT
M03C0016

GROUNDING

TANKER *EMERALD STAR*
APPROACH TO PURVIS MARINE LIMITED DOCK
SAULT STE. MARIE, ONTARIO
15 APRIL 2003

Report Number M03C0016

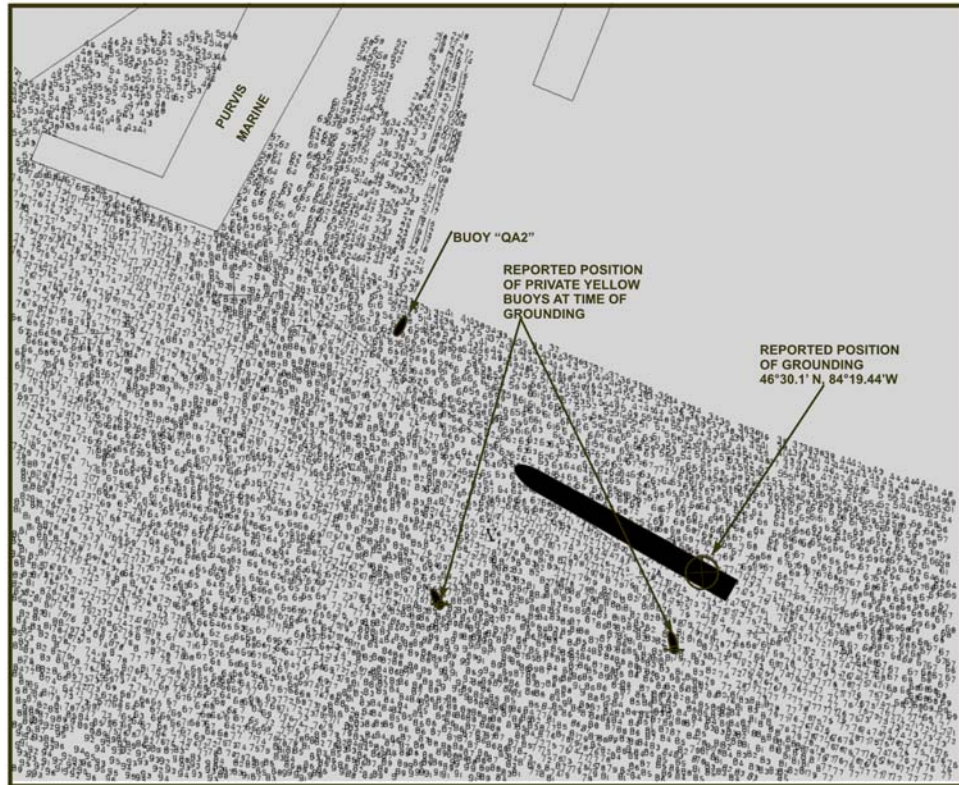
At about this time, a worker at the pump station at the end of the PML dock noticed that the vessel was proceeding outside the yellow buoys and informed PML staff. PML called the *Emerald Star* on VHF radiotelephone to warn the vessel to stay in between the buoys. Shortly after the call and before the master was able to change course, the vessel went aground at 1545. The reported position of the grounded vessel was 46°30.1' N and 084°19.44' W, approximately 1.4 cables off the dock but within the easternmost outer limit of the approach depicted on U.S. NOAA chart 14884. A sketch of the occurrence area is shown in Appendix A. Figure 1 shows the reported position of the grounded vessel in relation to the yellow buoys.

Figure 1. Reported position of the grounded vessel in relation to the private yellow buoys
